Manhole Inspection Summary

Manhole # S25GG1017MH

Location Address: **4001 FALLS RD**

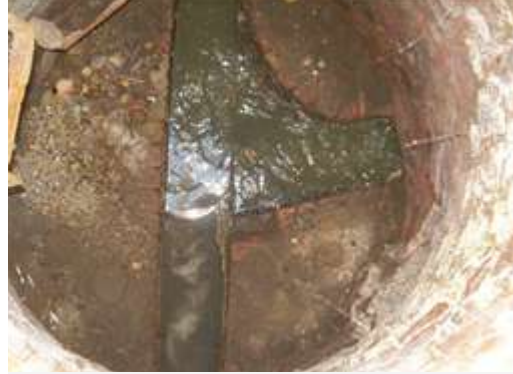
Top View

Corroded steps. Evidence of surcharge - Bench debris. Channel debris.

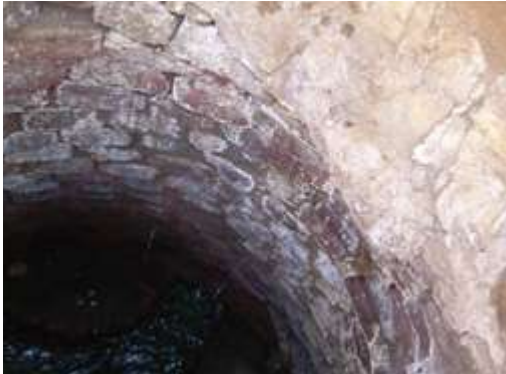
Defect

Frame leaks. Corbel deterioration, loose brick and infiltration. Barrel infiltration.

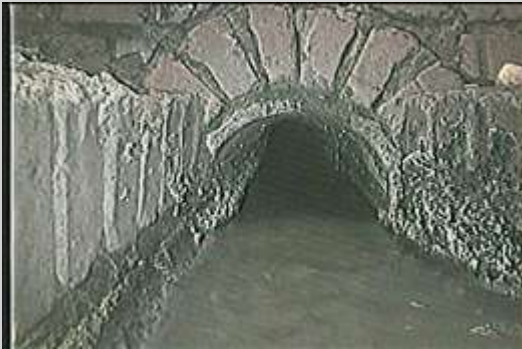
8 in. Circular Gravity Sewer Pipe Out @ 12 O'Clock

Deposits: ☐ None ☒ **Mud** ☐ Sludge ☒ **Debris** ☒ **Grease**

Silt Depth: **1** (in.) Deposits Extent: **Light**

Infiltration: **Evidence** Pipe Seal Cond: **Unknown**

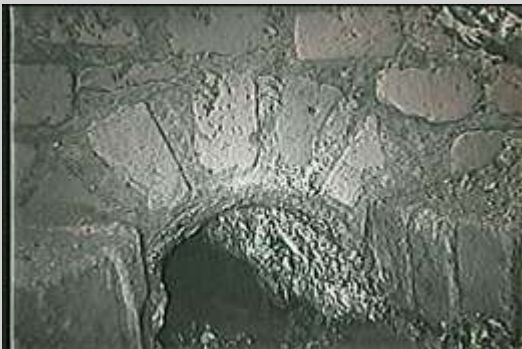
8 in. Circular Gravity Sewer Pipe In @ 3 O'Clock

Deposits: ☐ None ☒ **Mud** ☐ Sludge ☒ **Debris** ☒ **Grease**

Silt Depth: **2** (in.) Deposits Extent: **Medium**

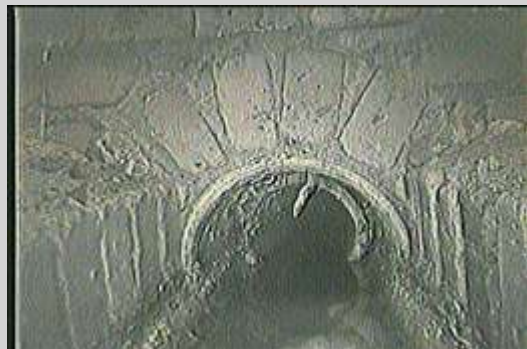
8 in. Circular Gravity Sewer

Deposits: ☐ None ☒ **Mud** ☐ Sludge ☒ **Debris** ☒ **Grease**
